STAINLESS-STEEL CONNECTION BRACKET TESTING

ATS JOB # 411882-R1

NORTHFORD STRUCTURAL CONNECTIONS
105 BARCLAY ST.
NEW HAVEN, CT 06519

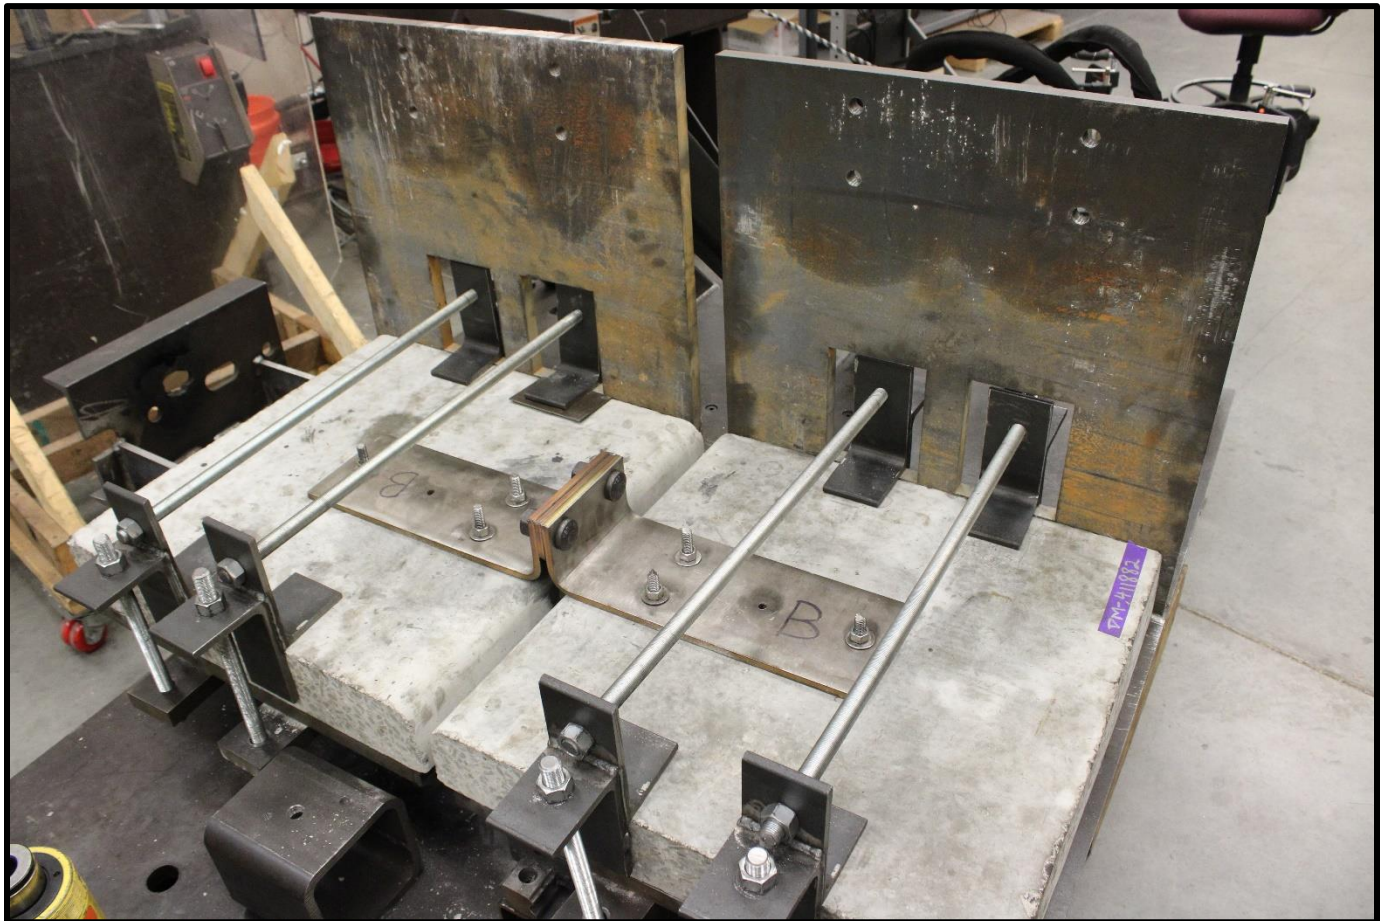
Figure 11: Bracket B - In-Plane Shear Test configuration

Bracket	Test	Total Cycles	Maximum Load (lbf)	Displacement at Max Load (in)	Observations
A	In-Plane Shear	10	9,942	2.43	Concrete fracturing and crack propagation prevented the sample from reaching 10,000 lbf. Maximum displacement reached was 2.71".
B	In-Plane Shear	10	10,113	1.99	Concrete fracturing created noise in the data acquisition. Maximum displacement reached was 2.00".

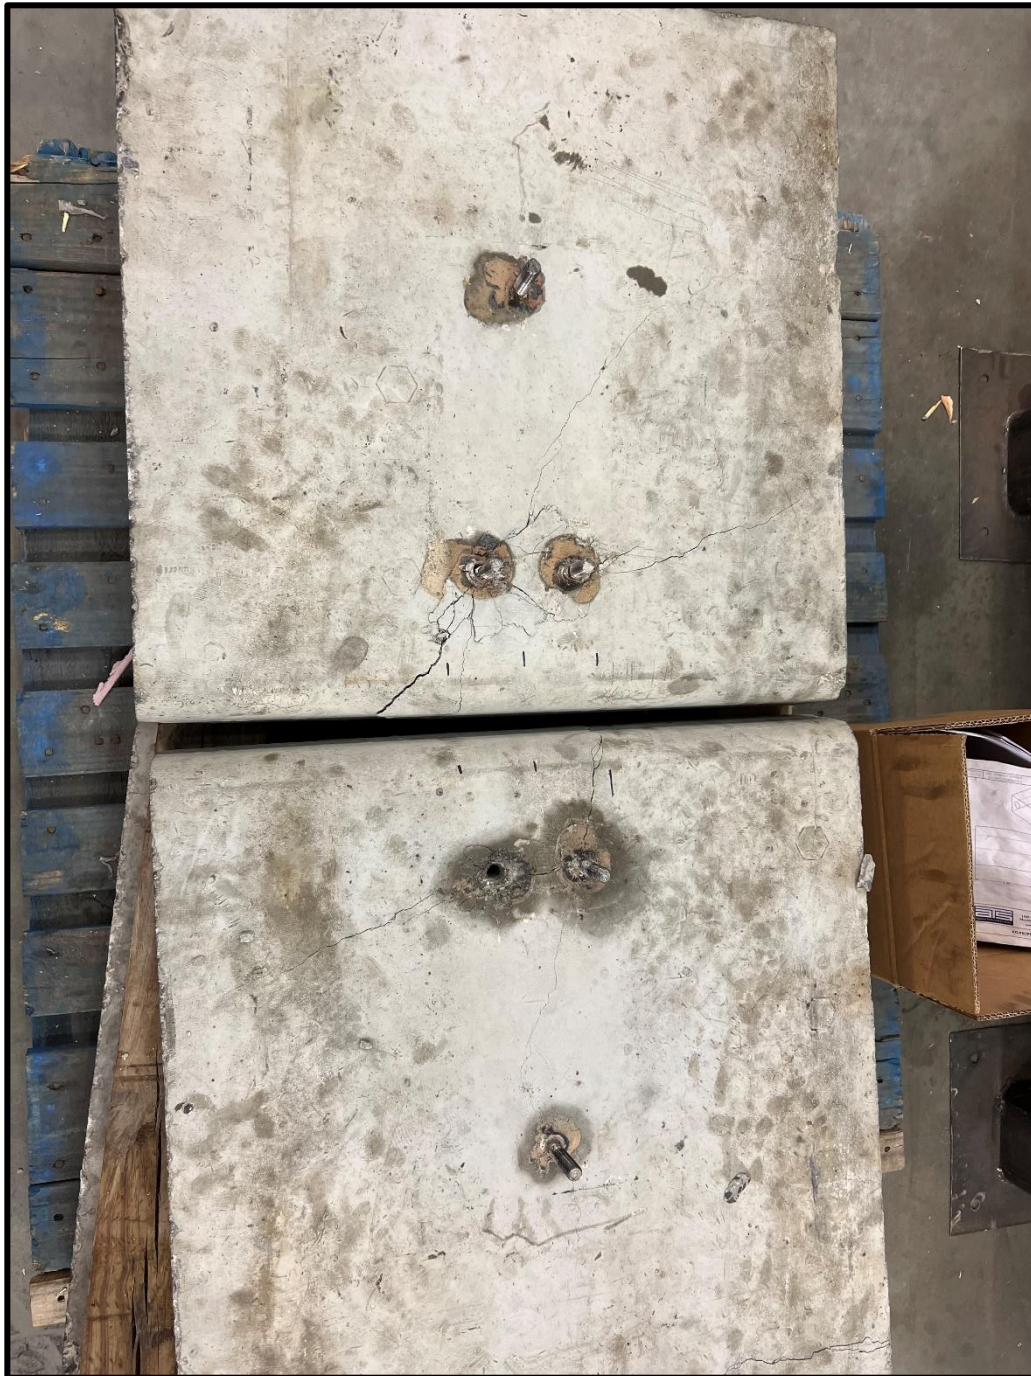
Figure 12: Visible crack formation on the concrete slabs after bringing Bracket B to 10,000 lbf during In-Plane Shear Test

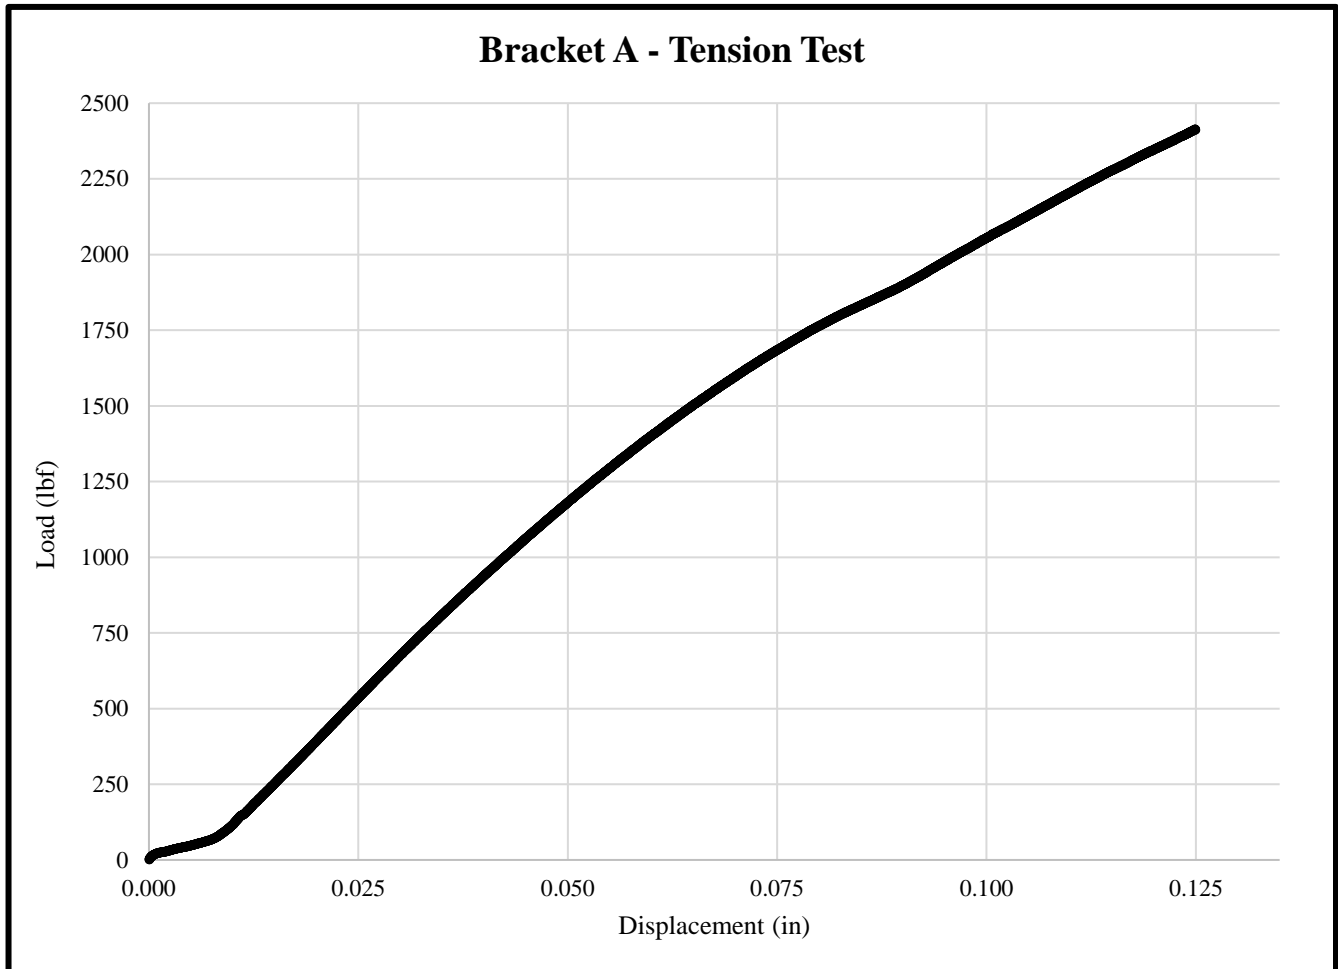
Figure 13: Bracket A - Tension Test data acquisition

Bracket	Test	Maximum Load (lbf)	Maximum Displacement (in)	Observations
A	Tension	2,413	0.125	During the Tension and Compression Tests, the brackets successfully reached the target displacement of ±0.125".
A	Compression	-2,731	-0.125	
A	Out-of-Plane Shear	1,000	0.341	
B	Tension	1,343	0.125	During the Out-of-Plane Shear Tests, the brackets successfully reached the target load of 1,000 lbf.
B	Compression	-3089	-0.125	
B	Out-of-Plane Shear	1,000	0.271

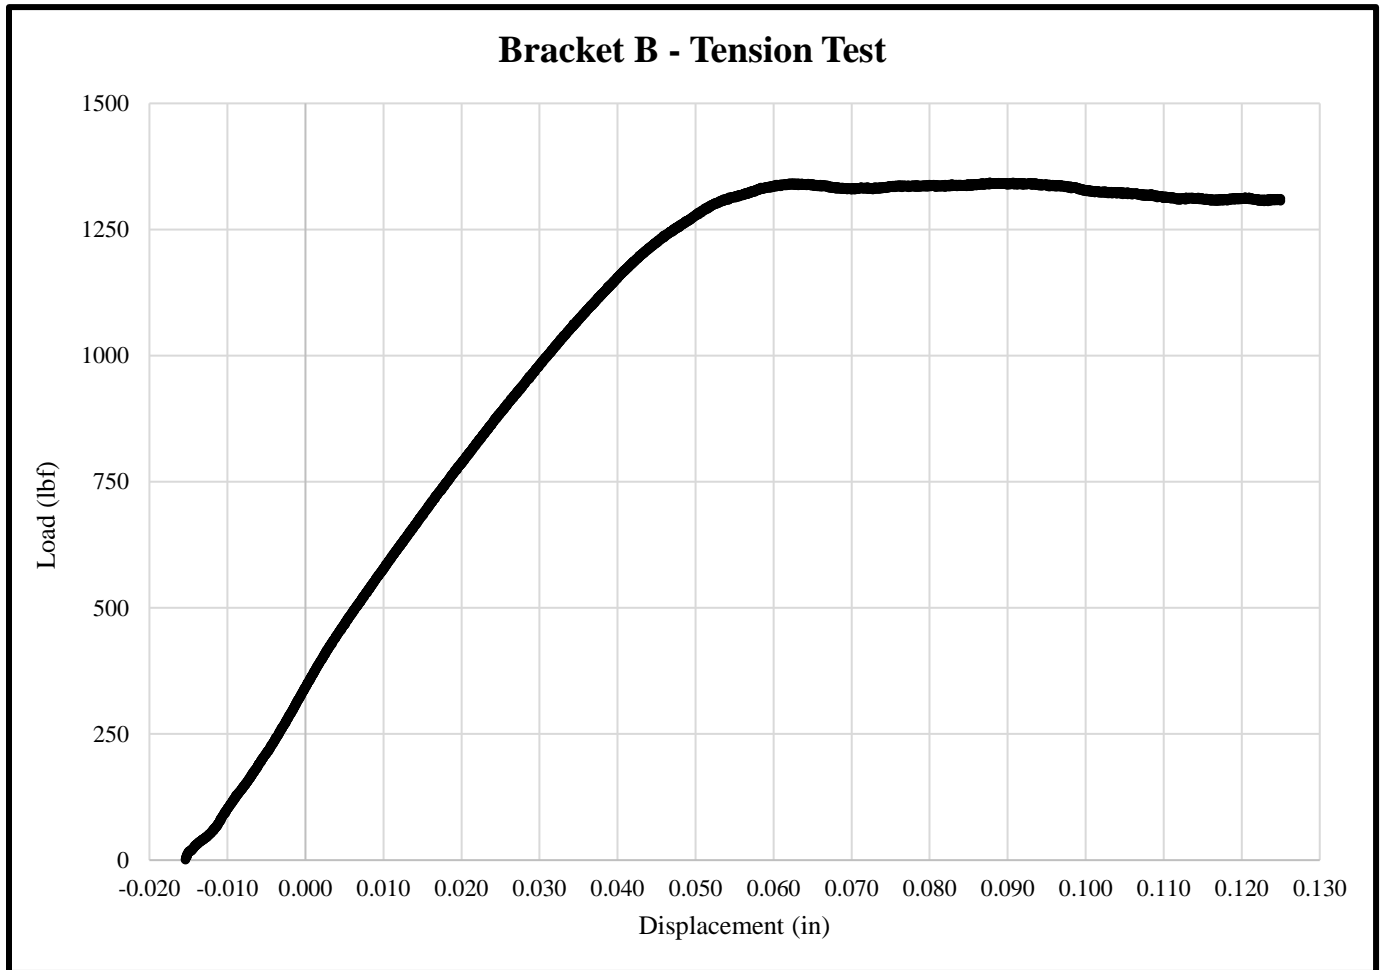
Figure 16: Bracket B - Tension Test data acquisition. Started immediately after Bracket B's Compression Test.

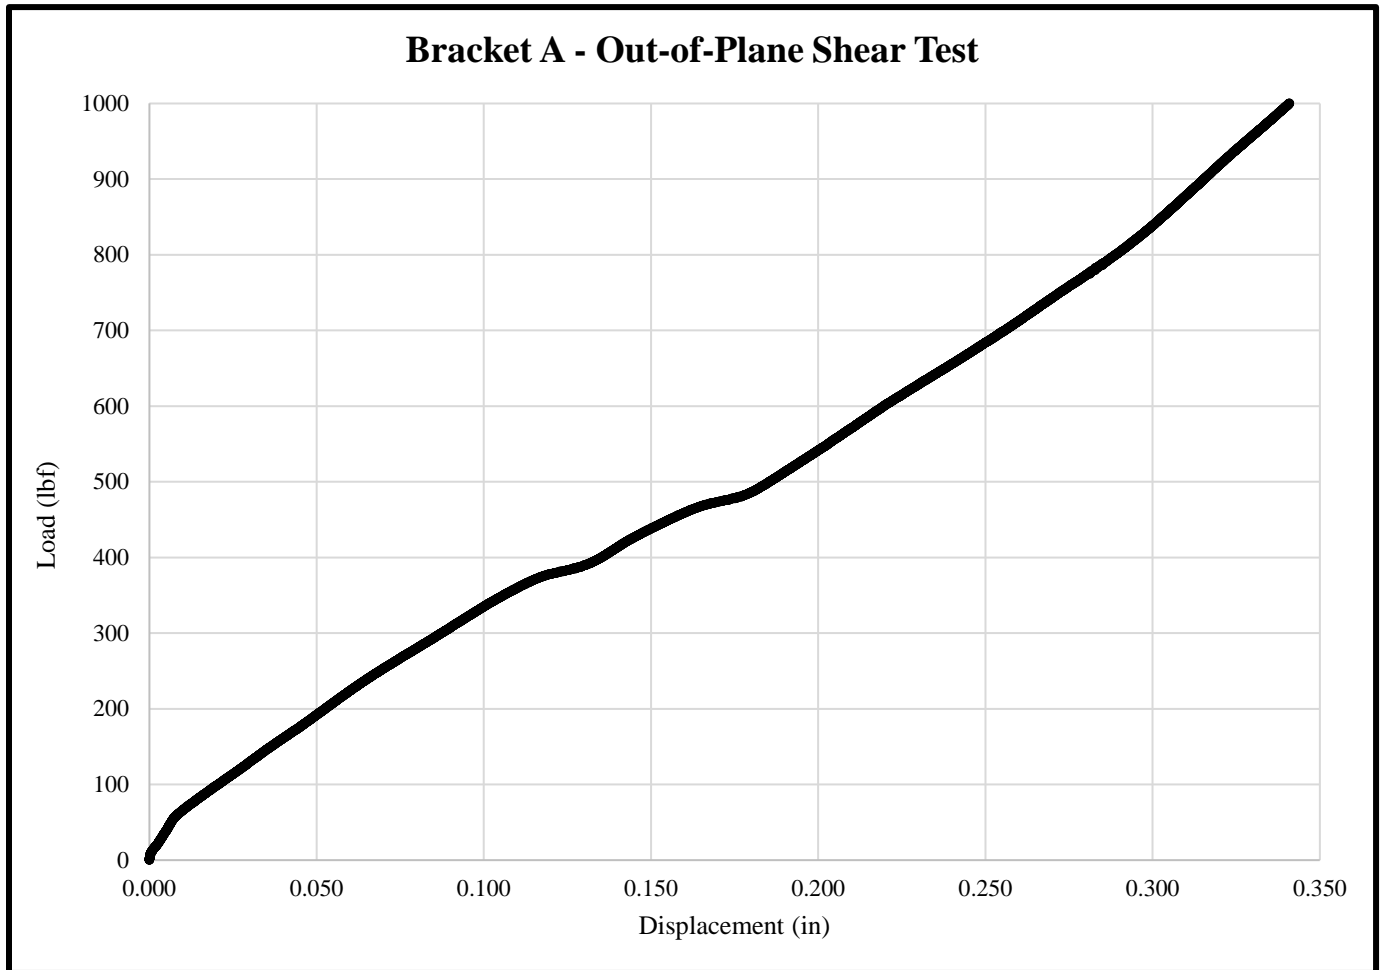
Figure 17: Bracket A - Out-of-Plane Shear data acquisition

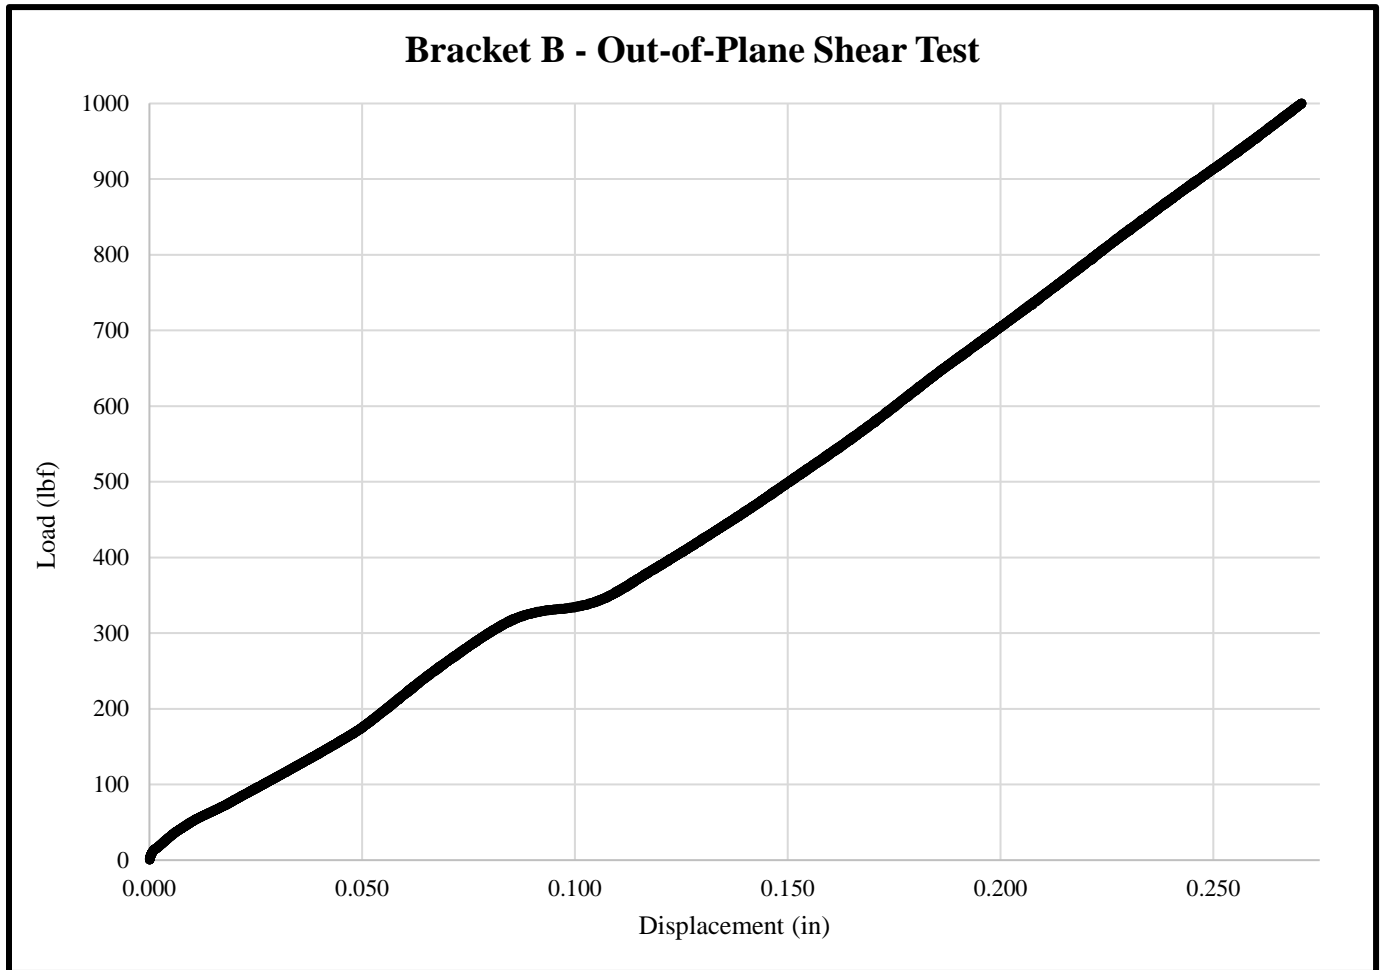
Figure 18: Bracket B - Out-of-Plane Shear data acquisition

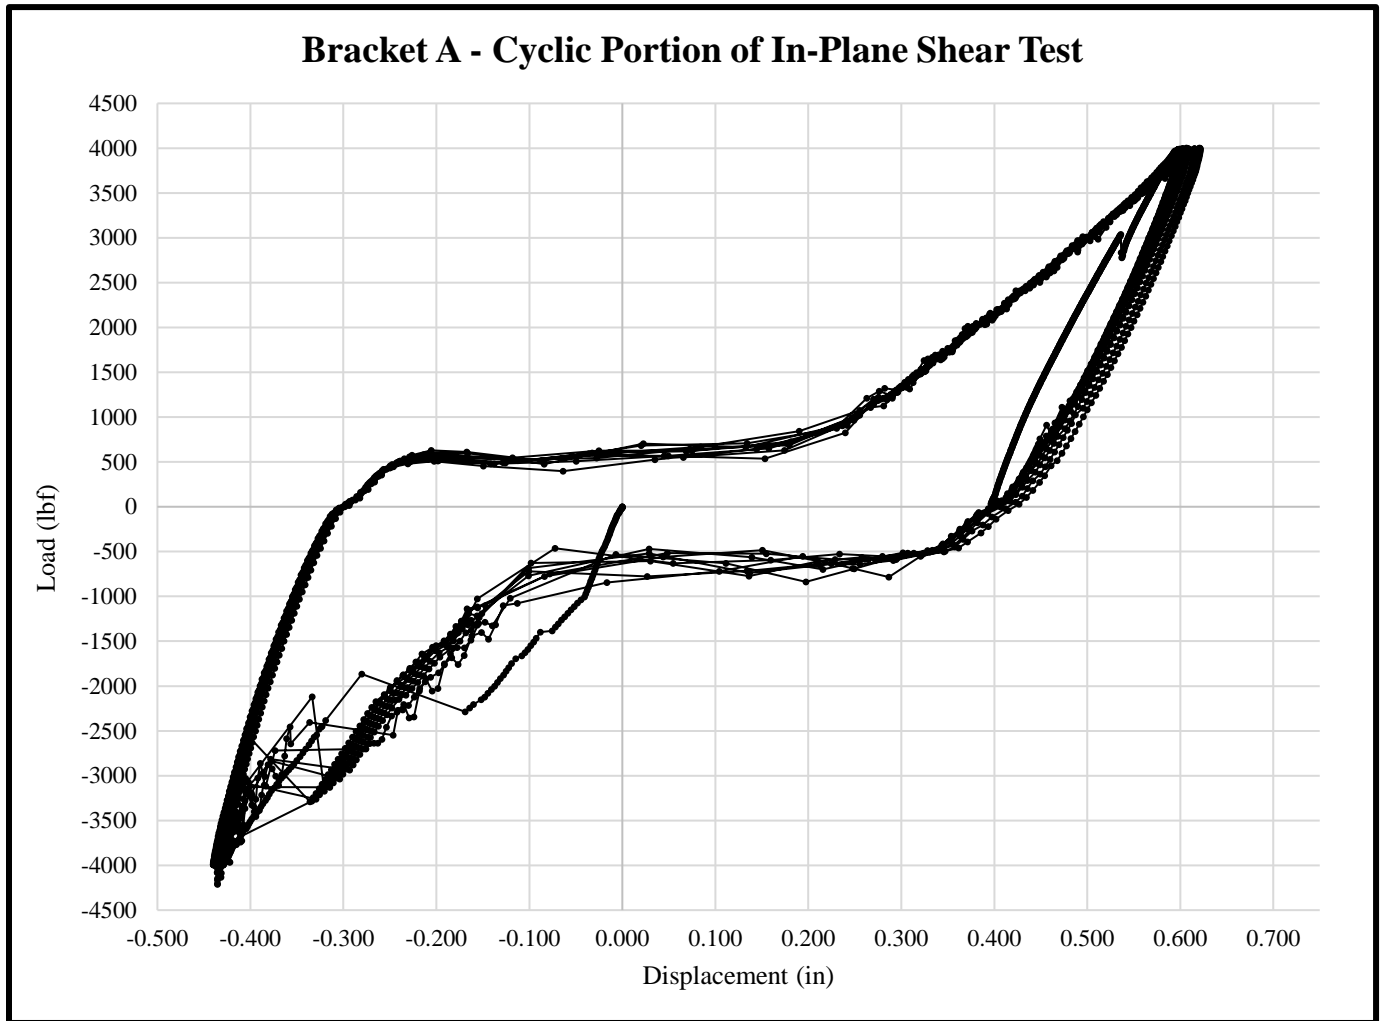
Figure 19: Bracket A – Cyclic In-Plane Shear data acquisition

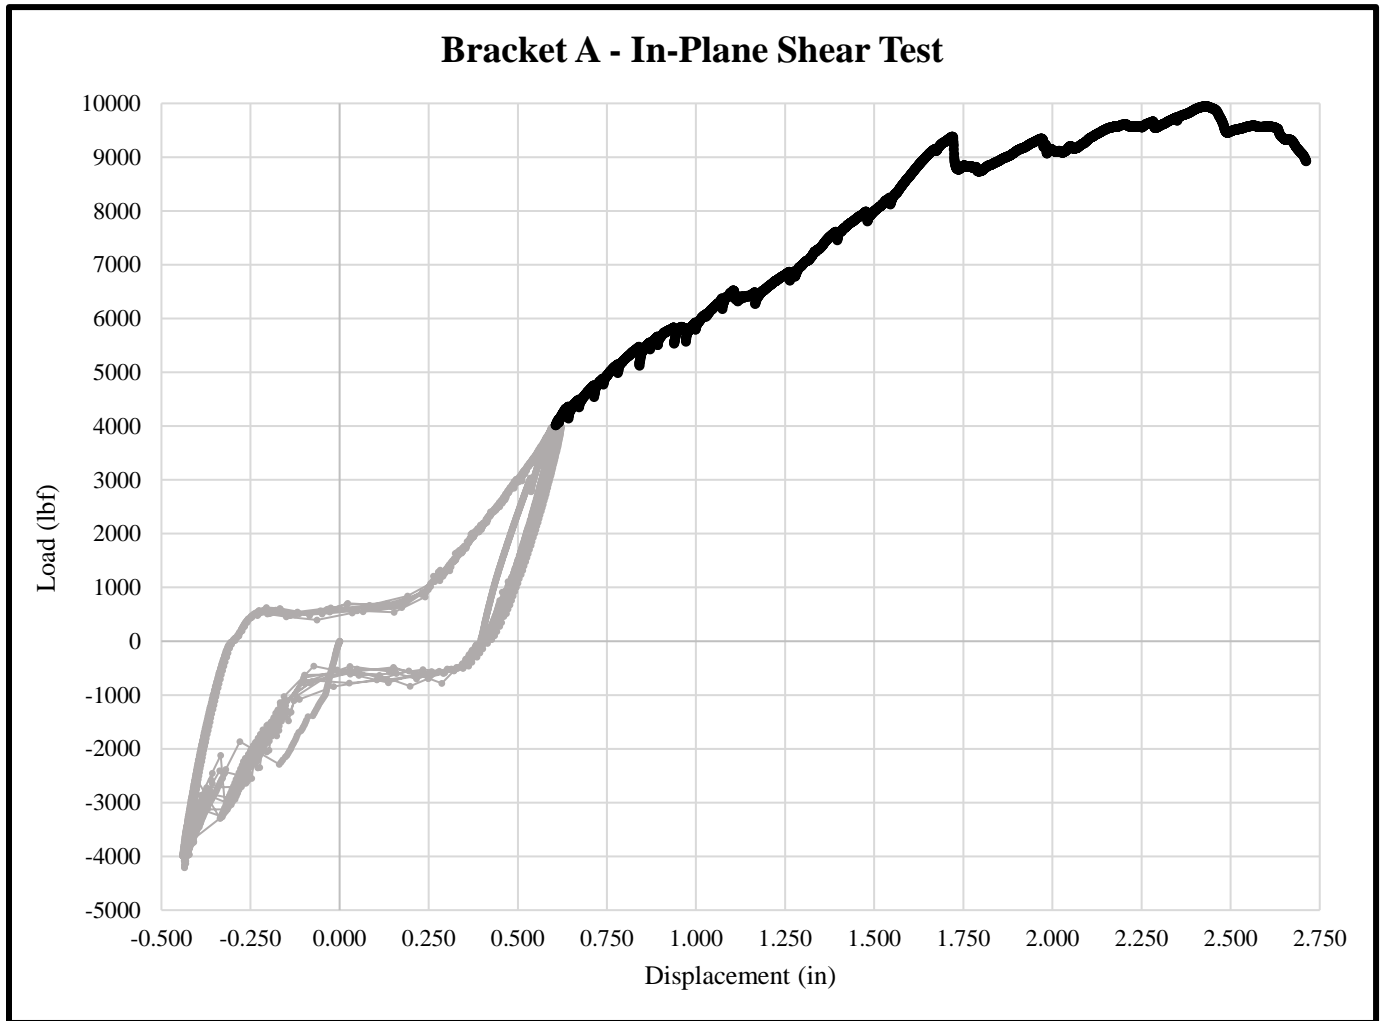
Figure 20: Bracket A – In-Plane Shear data acquisition. Concrete fracturing caused decreases in load when pulling to failure.
